SOLAR PROJECT

Solar Data Acquisition

1/12/2013

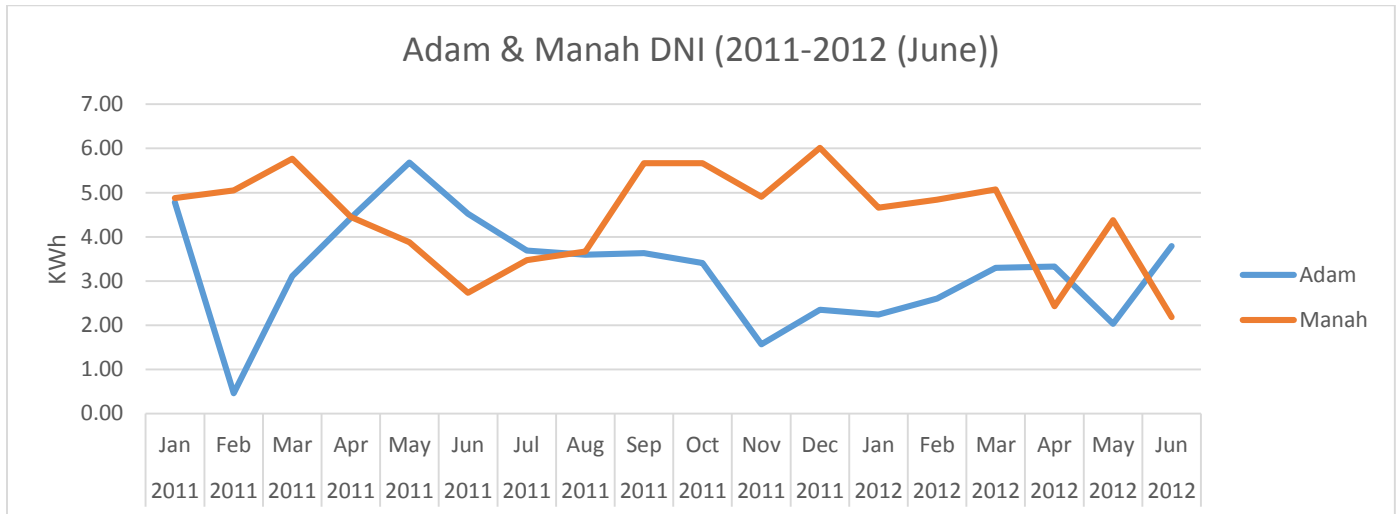
Graph 2.1: Adam & Manah DNI Data 2011-2012 (June)

During early 2012, OPWP became involved with the Solar Project, and more specifically with the two weather monitoring sites in Adam & Manah – this is due to the importance of the solar radiation data to OPWP as it is meant to be passed on during the development stage of the solar power plant. However, the DNI data presented to OPWP by the MET Department (who was initially responsible for the operations and maintenance of the sites) raised questions and doubts due to its inconsistent and erratic trend. The graph below represents the data trend during the time period before OPWP took action to resolve the issues that were present on site:

It's worth to note that this graph is slightly different from the one that was presented in the previous report as this shows the actual data presented from the sites, without eliminating days that did not register DNI readings (previous methodology).

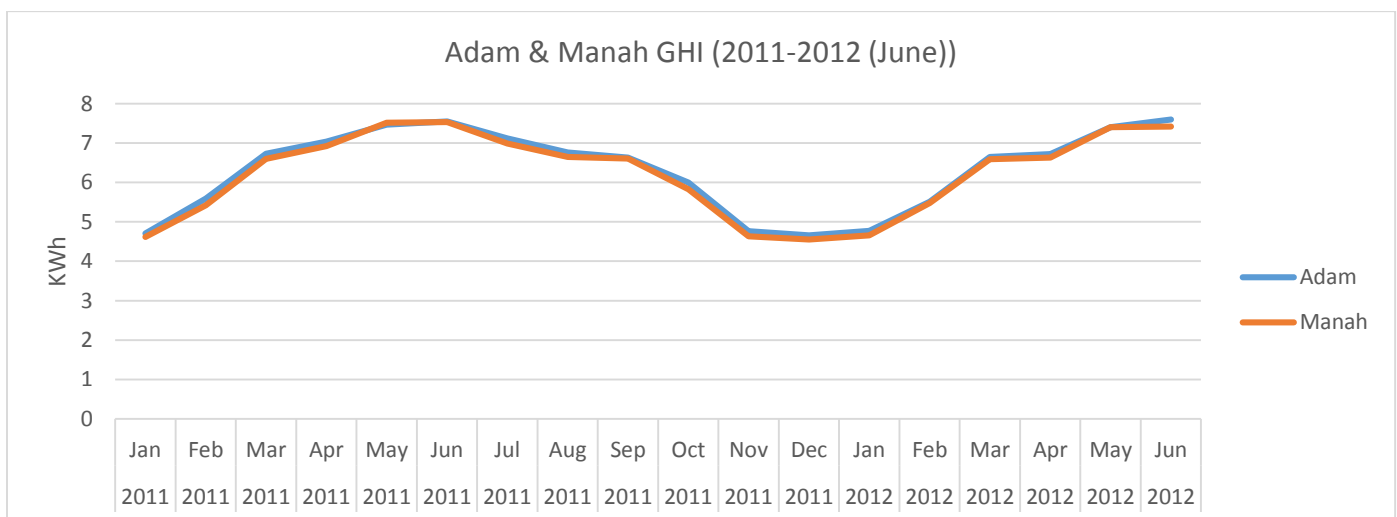
Graph 2.2: Adam & Manah GHI Data 2011-2012 (June)

In comparison, the below graph shows the GHI data measured for the same period.

It was due to the immense difference between the GHI and DNI data that OPWP decided to conduct its own investigation to determine the issues behind the inconsistent and erratic DNI data, and with the collaboration of our consultants provisioned for this part segment of the Solar Project, Worley Parsons, the supplier of the equipment and installers of the sites, Microstep, and the manufacturer of the sun sensors, Kipp & Zonen, it was determined that the issues with the data was not due to improper interpretation methodology of the data, but rather the sites themselves. This was due to the following factors:

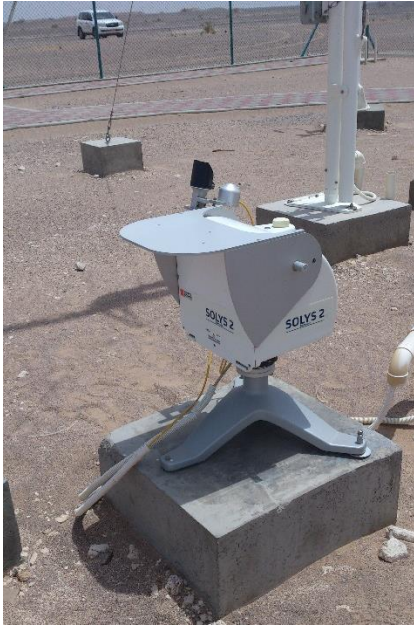
Image 3.1 Initial placement of Pyrheliometer

3. Improper placement of the Pyrheliometer:

In order to ensure that the pyrheliometer is not affected by the surrounding instruments, such as the mast that holds up the wind direction and wind speed sensors, a survey of the area was conducted and a new location for the unit was determined. In order to ensure that stability of the unit, a 1.2 meter concrete plinth was constructed and the pyrheliometer unit was installed on the plinth.

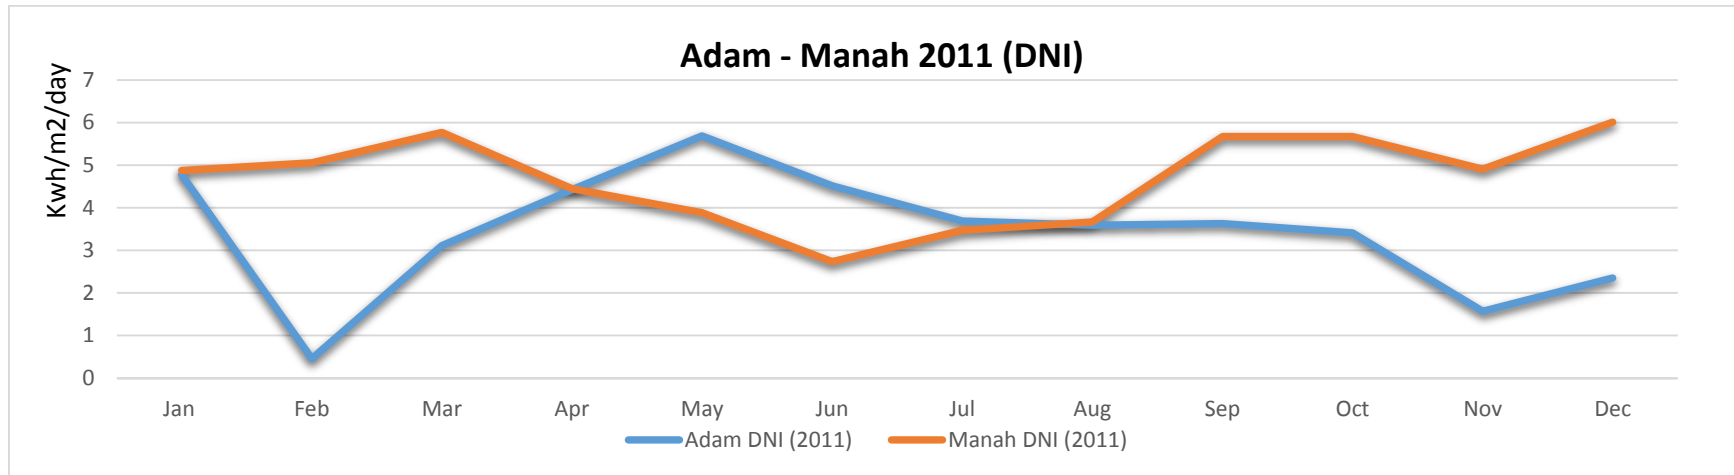
Graph 5.1 Adam & Manah 2011 (DNI)

The preliminary results of the efforts put in by OPWP show improvements in the data when compared to that previously obtained. Not only is the DNI trend far more stable than it was in the previous years, but it's also showing an increase in measured monthly average DNI data from 0.4 to 2.7 kWh/m²/day when comparing the newly obtained 2013 data to its respective months in both 2011 and 2012.

The below graphs shows the improvement in measured DNI when compared to the previous two years:

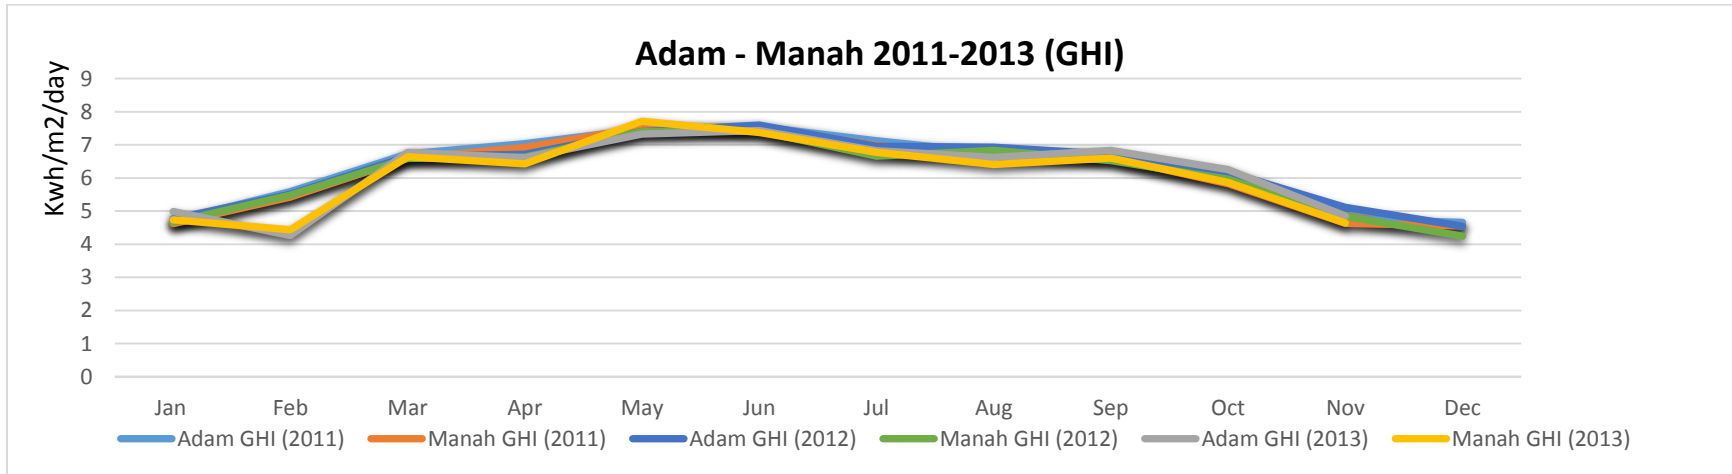
Graph 5.4 Adam & Manah 2011-2013 (GHI)

With regards to the GHI data, no real change can be observed. This implies that the available GHI data for the years 2011 & 2012 is indeed accurate and reliable data.

The below graphs shows the consistency in the GHI data throughout the years, and thus is deemed to be reliable and accurate data:
